Valley View Farm: Main House

Valley View Farm Main House

Cartersville, Georgia

Historic Structure Report

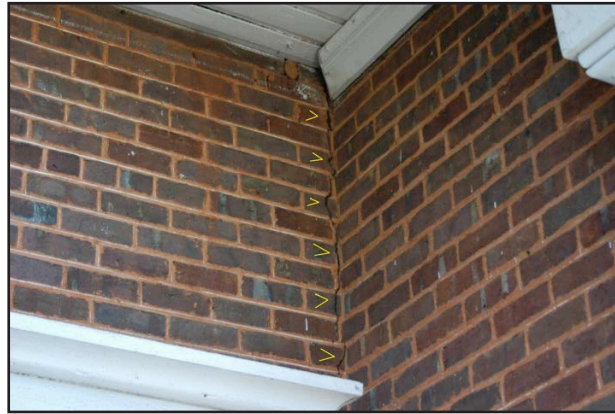
figure 2.19. South wing wall (left) meets the I-house section (right) first floor. Yellow arrows point to bricks exposed as being interwoven because they are broken. House movement caused the breaks.

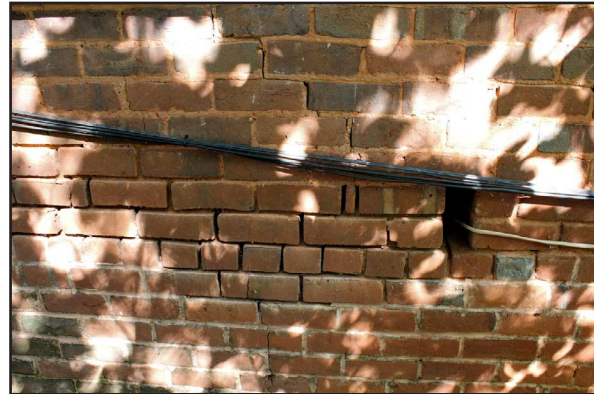
figure 3.35: ventilation hole on south façade with electrical wires

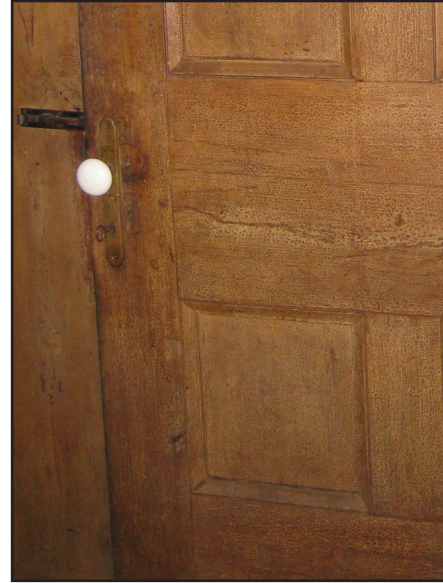
figure 3.51: sagging and drips in the finish on door in Room 111

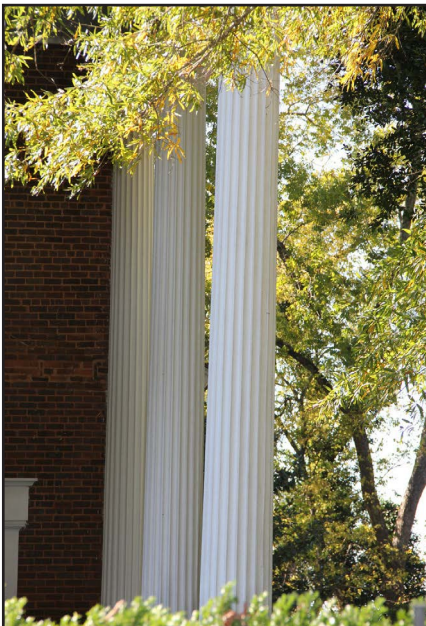
figure 4.2, figure 4.3 (below): both images show bowing of front columns.

The columns were an area of major concern during the site review. Tapping on the column confirms that the exterior is made up of relatively thin staves, with the interior being hollow. These columns are typically loadbearing, with the weight of the entablature spread out among the staves by the cap. The paint on the wood column surface is in poor condition in spots (*fig. 4.1*). These tongue and groove column pieces will deteriorate rapidly without adequate paint coverage, especially on the bottom 6". Several of these columns also appear to bow when looking at them from a distance and when sighting up the columns towards the roof (*fig. 4.2*). Because of the critical nature of these columns, a high priority needs to be placed on their repair and continued conservation so that they can continue to carry the roof load. The bases of the columns are made up of several pie-shaped wedges of wood. Some of these bases are in good condition (*fig. 4.4*), some are in poor condition or missing altogether (*fig. 4.5*). Under these thin wood bases are brick bases and, like the columns, some are in better condition than others. Some appear structurally solid, and others are crumbling (*fig. 4.6*). The columns and bases that need the most monitoring and attention are the two immediately north of the main entrance door. The half columns on the northern and southern ends of the house are in best condition; this may be due to increased ventilation permitted by the gap between the wing wall and the column interior. The Ionic capitals on the top of all of the columns are in good condition. There is some cracking of the paint, but the wood beneath appears to be sound.

- Several of the columns on around the front porch were noted as being bowed out of plane. Since these columns are the only support for the porch ceiling and roof, they should be a priority in both maintenance and repair. It is highly recommended that a structural engineer evaluate the integrity of the columns and porch ceiling structure. Each column and several points along the porch entablature should be monitored by reference points and baselines to discern changes in the structure that may be reflected in the columns movement.

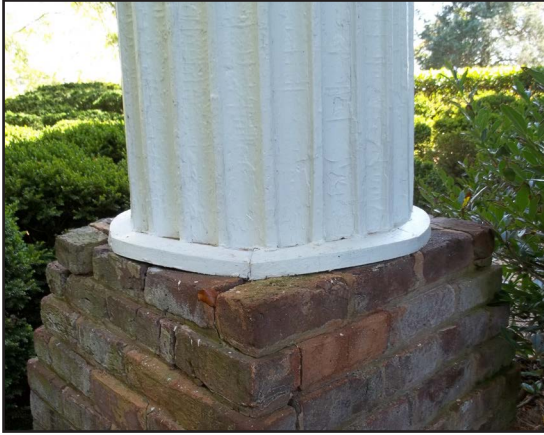
figure 4.4: column base in good condition

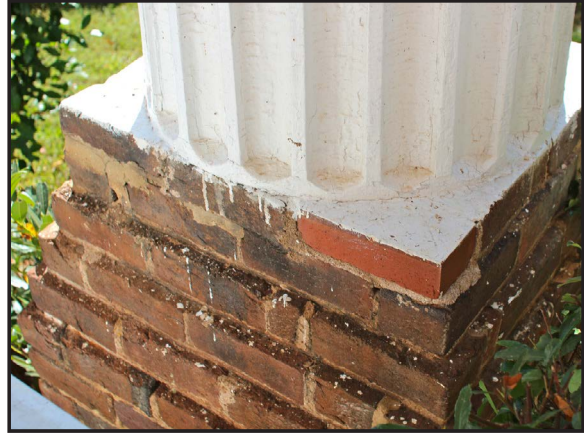
figure 4.5: round column base missing

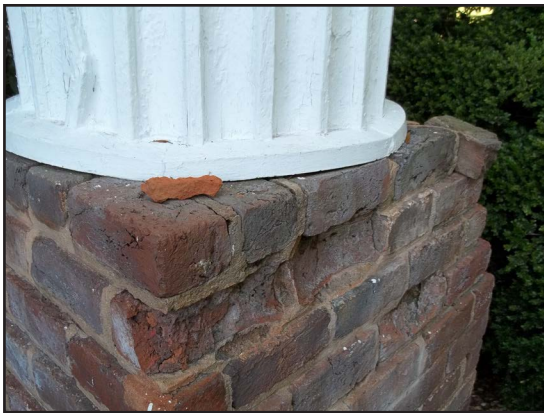
figure 4.6: crumbling brick base.

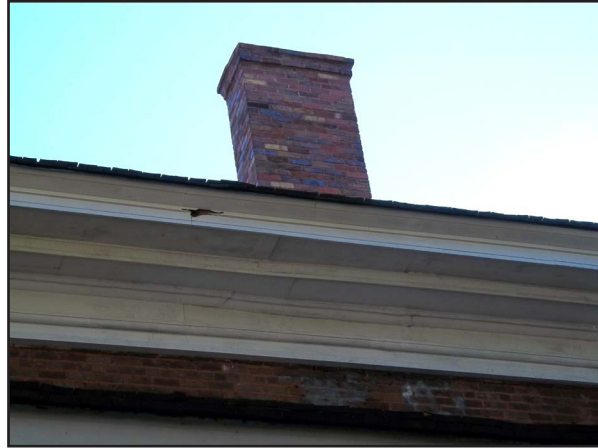
figure 4.14: Courtyard, sagging trim assembly

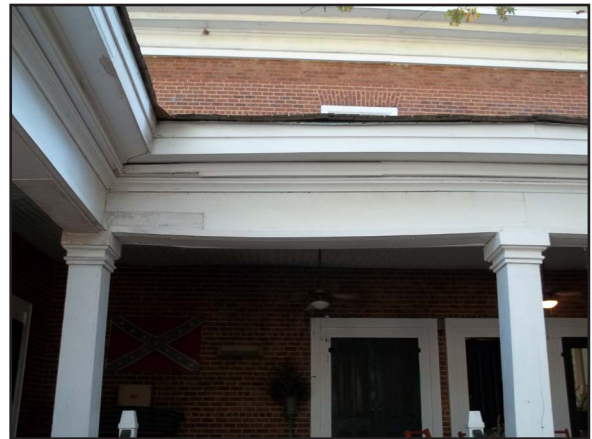
figure 4.15: Courtyard, sagging trim assembly

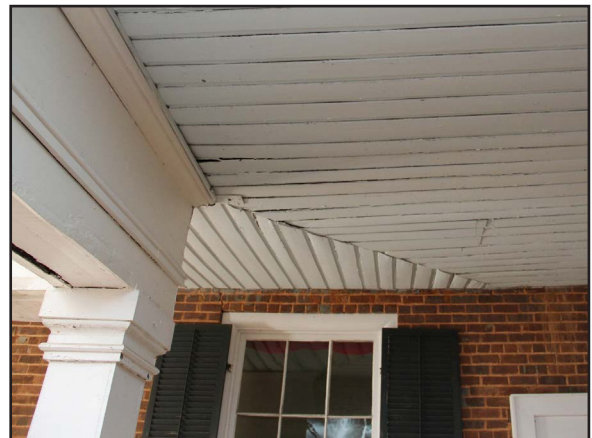
figure 4.16: interior northeast corner of back porch where leaks have been reported.

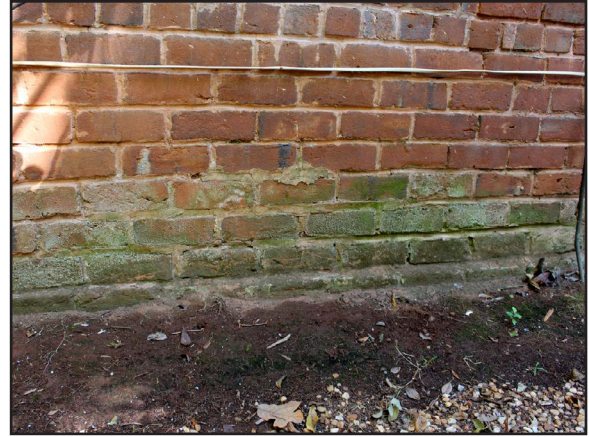
figure 4.17: eroding foundation and mold problem due to moisture near the ground.

Additionally, minor repairs need to be made to the windows and a hole in the cornice on the west façade of the I-house section should be fixed. A moisture problem around much of the exterior brick foundation should be addressed to prevent major deterioration from occurring in the future.

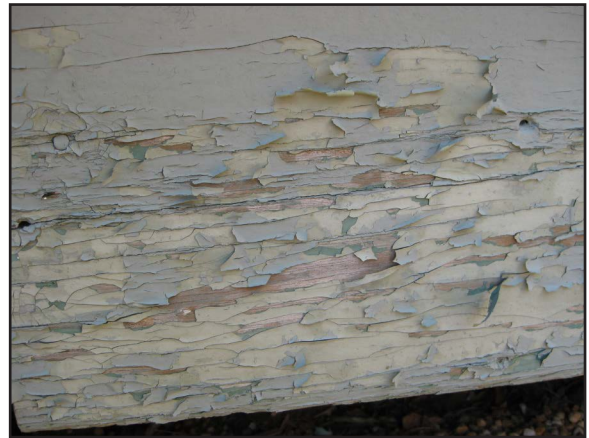
figure 4.18: peeling paint on porch

- No major decay mechanisms on the wood trim were visible, however, the paint on the front porch and rails is cracking to the point of exposing the wood underneath and needs to be scraped, repairs to the wood made with a wood filler and the porch and rails repainted. A professional should be hired to make sure the painting is done properly.

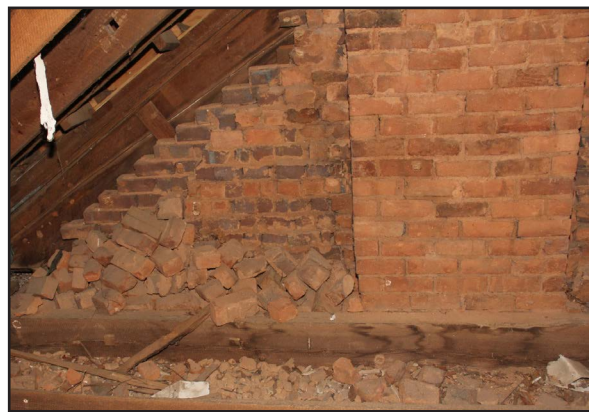
- 1 This explanation is also consistent with the fact that the gable walls have a design flaw: the brick layers are inadequately bonded, resulting in two of the present walls being in a state of collapse inside the attic. The south wing west end and the north wing east end have had the innermost brick layer fall inward and collapse. An examination from inside the attic reveals that there were no bond courses. The brick rubble lies in a heap for the south wing, but has been removed from the north wing .

figure 4.24: collapsed wythe of brick in Attic 302.

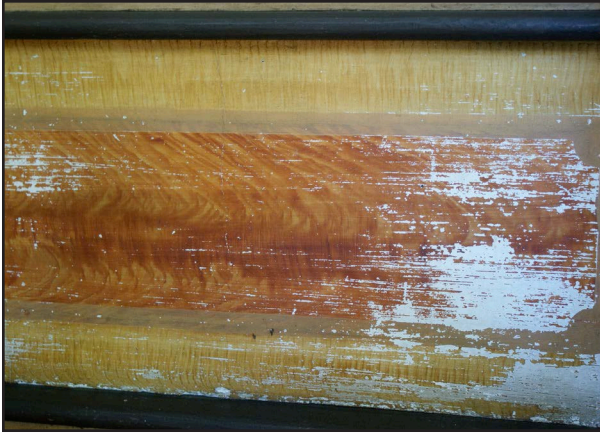
figure 4.26: (unmentioned): scuffed faux painting within panels is a common problem throughout the house. Here the plaster shows beneath the paint in Room 103.

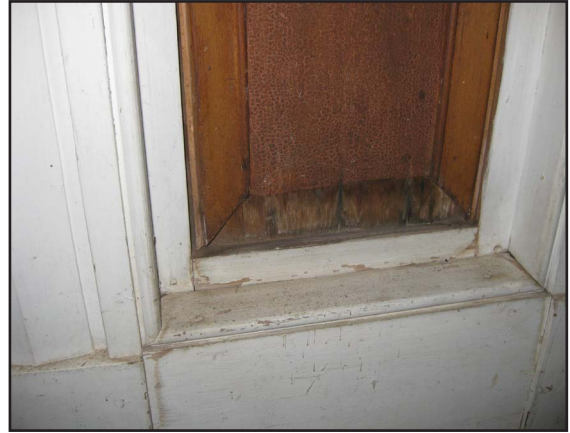
figure 4.27: trim missing, Room 100

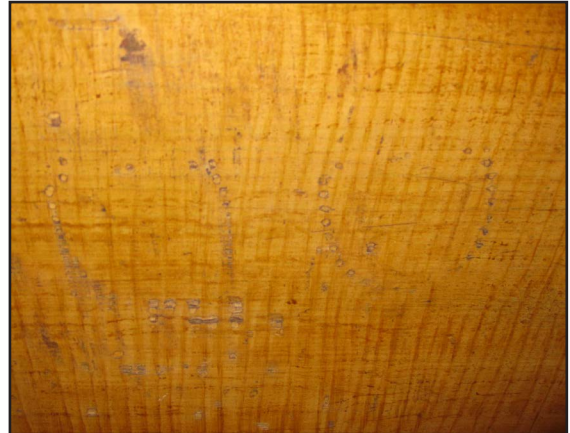
figure 4.29: horseshoe imprint on interior of door, Room 102

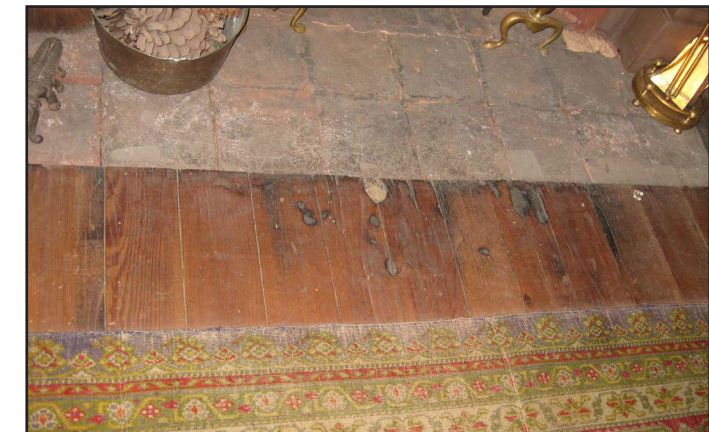
figure 4.31: burn marks on floor by hearth and a hole filled with spackle, Room 103

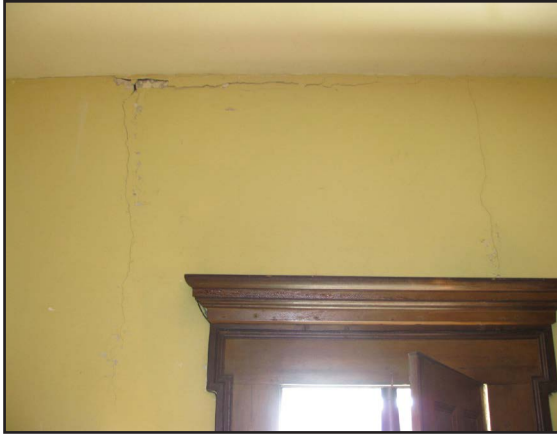
There are major cracks in the plaster on the east wall above the door leading to room 101 (porch), starting halfway up the wall to the left of the door and extending across the wall and running down the wall to the right of the door. There is a section where the plaster has been damaged significantly and a large chunk of plaster is missing (*fig. 4.32*). There is also a

figure 4.32: Room 104 plaster cracks

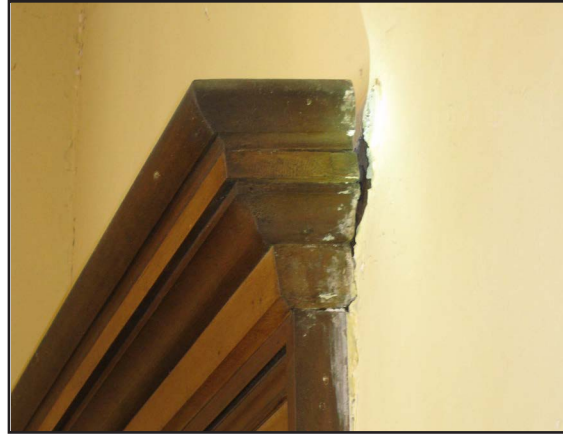
figure 4.33: Room 104, cornice pulling away from the wall

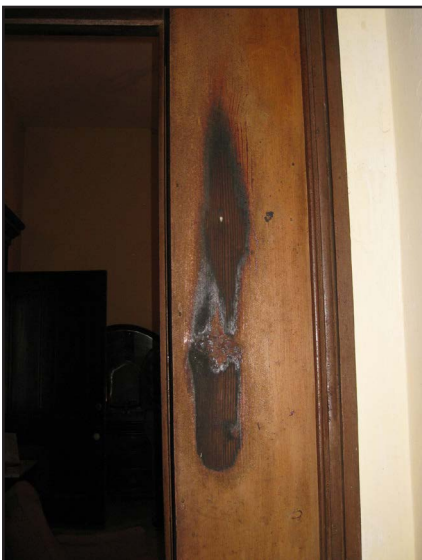
figure 4.36: Room 105 burn mark on door frame

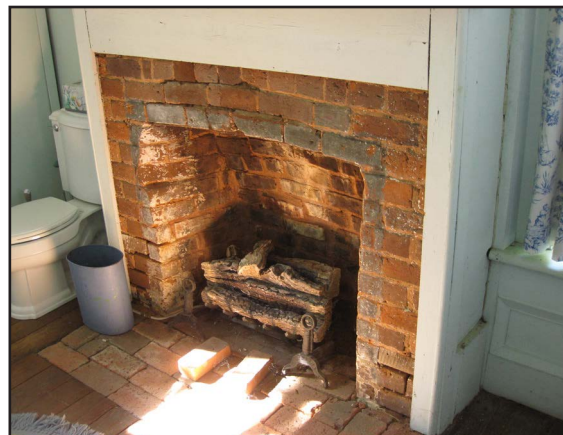
figure 4.37: Room 106, cracked bricks in fireplace and mantle

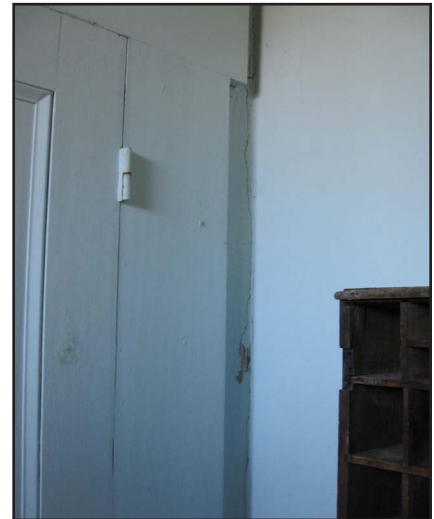
There is a crack in the plaster on the northeast corner extending from floor to ceiling (*fig. 4.38*) and running along the ceiling to the south, multiple plaster cracks in the ceiling itself, peeling paint on the east wall and on the door frame leading to room 106A (closet). There are cracked bricks in the fireplace with missing mortar (*fig. 4.37*), as well. The plaster is separated from the door frame leading to the outside and more peeling paint.

*figure 4.38: Room 106,
plaster crack*

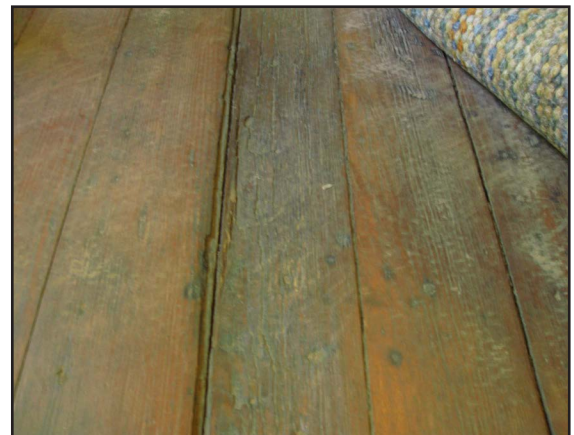
There is a crack where the wall and ceiling meet to the right of door to room 109 (laundry), extending down to the southeast corner. There is another crack on the ceiling in the northeast corner and one on the ceiling above the north window extending to the west wall, where it runs along the corner of the wall and ceiling to the southwest corner. Paint is peeling on the north part of the ceiling. There is a hole in the wood floor in front of the fireplace to the left. To the south of the trap door, the wood floor board has been worn to a groove, revealing the tongue (*fig. 4.39*).

figure 4.39: Room 108, worn floorboard

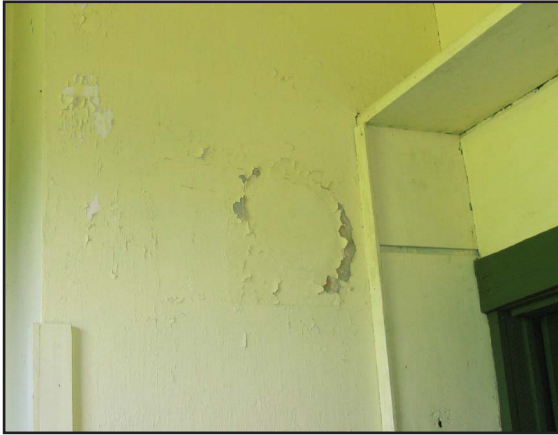
This room was in the worst shape of any of the rooms. There are dark spots in the middle of the ceiling, peeling paint on every wall (*fig. 4.40*) and the ceiling, a crack in the

figure 4.40: Room 109 peeling paint

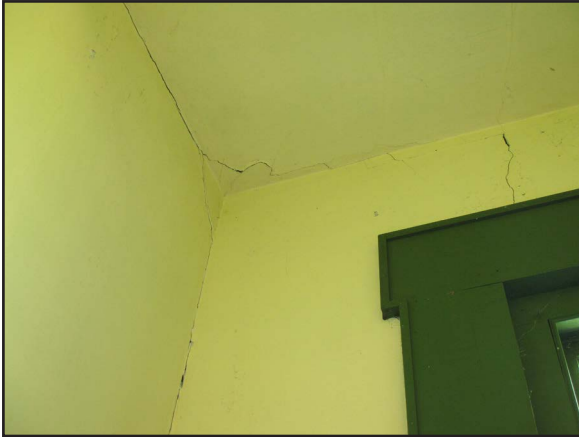
figure 4.42: Room 109, plaster cracks

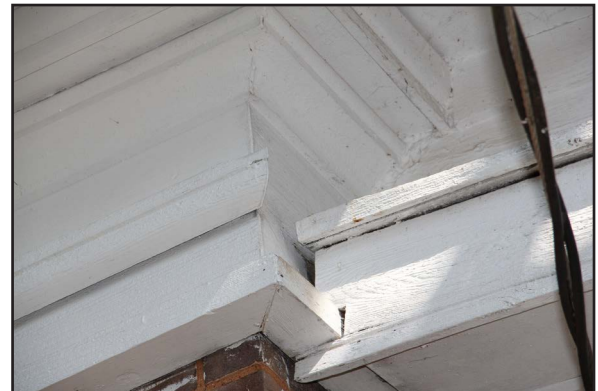
figure 4.50: electrical wires running around the exterior molding of the back porch.

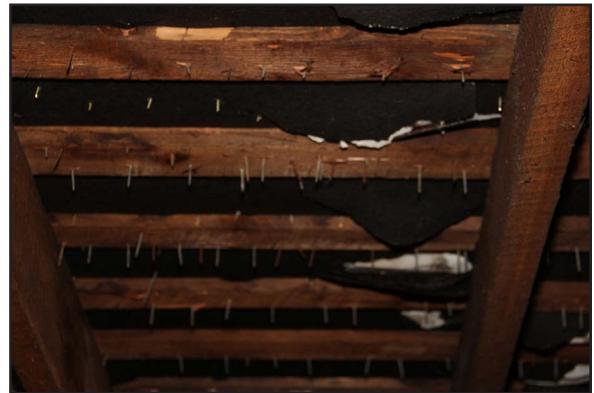
figure 5.2: decking, sheathing and protruding nails in attic
